# Manhole Inspection Summary

Manhole # S170\_\_007MH

Insp Date: **3/10/08 11:54 AM**

**Location** Address: **2655 st benedict st**

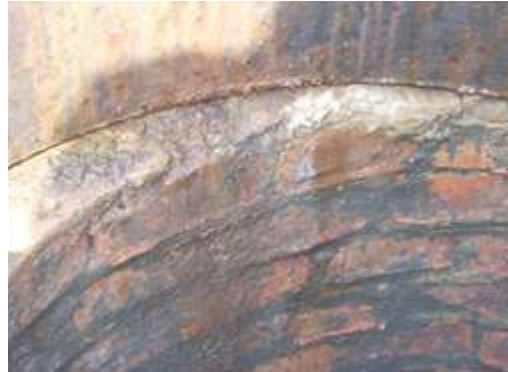
Defect 3

Infiltration: ☐ None ☒ **Joint** ☐ Cracks ☐ Mortar ☐ Roots ☐ Wall

infiltration @ the chimney joint

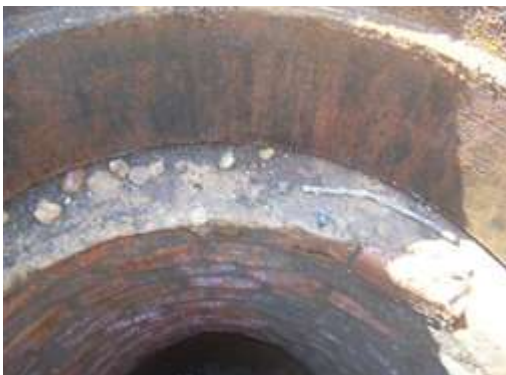
Defect 1

**Frame** Offset: **3** (in.) Condition: ☒ Sound ☐ Cracked ☐ Leaks

frame offset

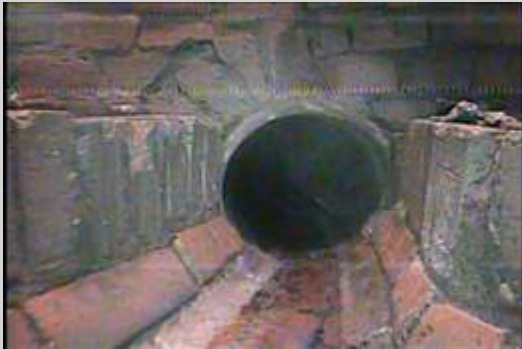
12 O'Clock Outflow

Pipe Height: **8.4** (in.) Rod and Bar (Angled)  
Pipe Material: **Clay** ☐ Pipe Lined  
Invert Depth: **9.35** (ft.) Flow Characteristics: **Slow**  
Deposits: ☒ None ☐ Mud ☐ Sludge ☐ Debris ☐ Grease  
Silt Depth: **0** (in.) Deposits Extent:  
Infiltration: **None** Pipe Seal Cond: **Sound**

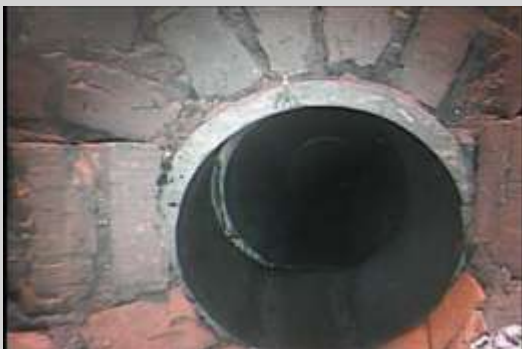
4 O'Clock Inflow

Pipe Height: **8.4** (in.) Rod and Bar (Angled)  
Pipe Material: **Clay** ☐ Pipe Lined  
Invert Depth: **9.30** (ft.) Flow Characteristics: **Slow**  
Deposits: ☒ None ☐ Mud ☐ Sludge ☐ Debris ☐ Grease  
Silt Depth: **0** (in.) Deposits Extent:  
Infiltration: **None** Pipe Seal Cond: **Sound**

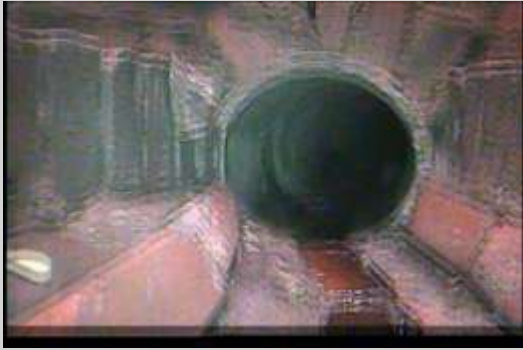
6 O'Clock Inflow

Pipe Material: **Clay** ☐ Pipe Lined

Invert Depth: **9.30** (ft.) Flow Characteristics: **Slow**

Infiltration: **None**

Pipe Seal Cond: **Sound**
